SAND 80-0808
UNLIMITED DISTRIBUTION

PROTECTIVE COATINGS AND SEALANTS FOR
SOLAR APPLICATIONS

K. B. WISCHMANN
M. H. GONZALES

Sandia National Laboratories

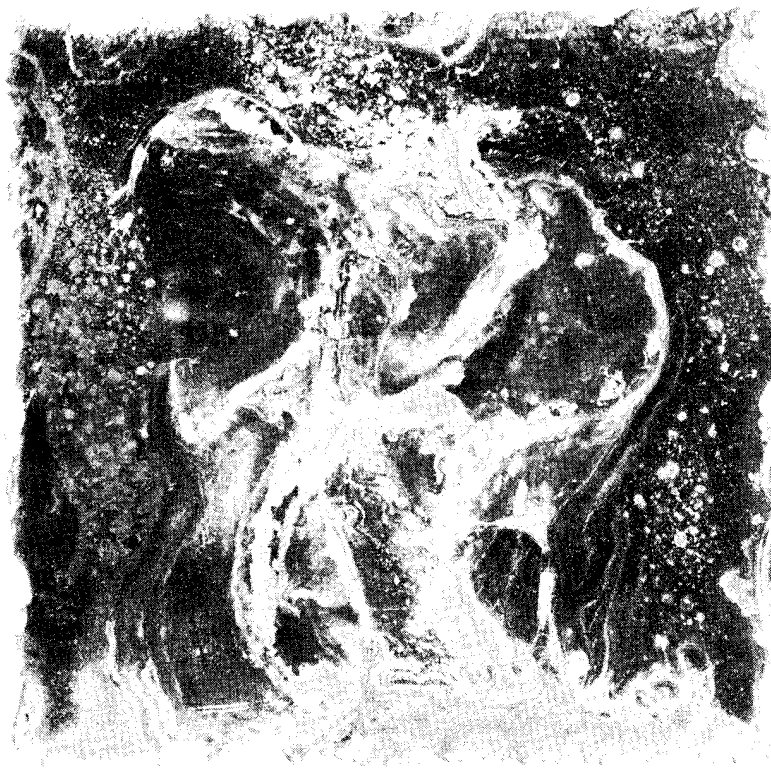
FIGURE 13

- Figure 11 Sine Wave Fiberglass Body and Face, GE-1200 Sealant
- Figure 12 Sine Wave Fiberglass Body and Face, DC-738 Sealant
- Figure 13 Sine Wave Fiberglass Body and Face, DC-790 Sealant

The sine wave fiberglass substrates sealed with either epoxy-fiberglass or melamine exhibited mirror deterioration after 6 months with increased degradation at 12 months (see Table 4 and Figures 11-16). Figures 11 and 15 are samples in which accidental impacts led to cracks. No deterioration was noted around the crack shown in Figure 11, whereas the sample in Figure 15 exhibited considerable pitting along the crack edges. In the first instance the bonding integrity of the silver and gray paint must still be substantial to preclude any silver degradation. In the latter sample, the bonding must have been weakened from the impact resulting in degradation. Post-mortem examination of the modules shown in Figures 11 and 12 dramatizes the degradation effects attributed to thermal expansion mismatches in sandwich heliostat structures. The sine wave ribs are perpendicular to the mirror surface and work against the mirror during thermal cycling causing debonding in the immediate contact area. This phenomenon provides a pathway for moisture to enter. Notice how the corrosion pattern replicates the sine wave structure. Mirror longevity is just as much a function of heliostat design as is material selection.

FIBERGLASS FACE
SINE WAVE FIBERGLASS BODY
